MSHA's Accident Prevention Program Safety Idea

Guardrails, Barriers and Floor Covers

Issued:	12/16/2008
Tag #	AP2008-0096071

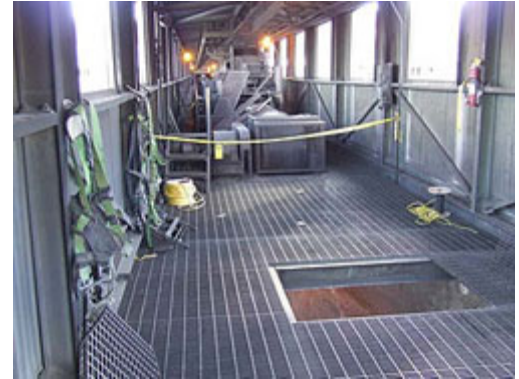
Recently a contractor consultant with 46 years of experience was fatally injured when he fell through a 4-foot by 6-foot opening 28 feet to the floor below. From 2000 to 2008, 72 Coal & Metal & Nonmetal miners were fatally injured from falls. In twenty-five of these fatal accidents, hazardous conditions occurred at elevated work surfaces such as at floor access openings or walkways where insufficient guardrails, barriers, floor covers or fall protection was used. Some of these accidents may have been prevented by simply replacing the floor coverings when the opening was not in use, or by providing barriers to eliminate the hazard.

- 1) Inspect the work areas for all potential hazards including places that persons may fall from or through.
- 2) Take time to plan the work to safely perform the job.
- 3) Always wear fall protection when there is a danger or potential of falling.
- 4) Protect floor openings and leading edges near travel ways by installing guardrails or barriers in addition to warning signs.
- 5) Keep temporary access opening covers or railings secured in place. Immediately reinstall access covers when not bringing items through the opening.
